International Conference on Case Histories in  
Geotechnical Engineering

## Failure of a Hybrid Flexible Shoring System for a 30m Excavation: Exploration of Causes and Remedial Measures

Salah Sadek

*American University of Beirut, Beirut, Lebanon*

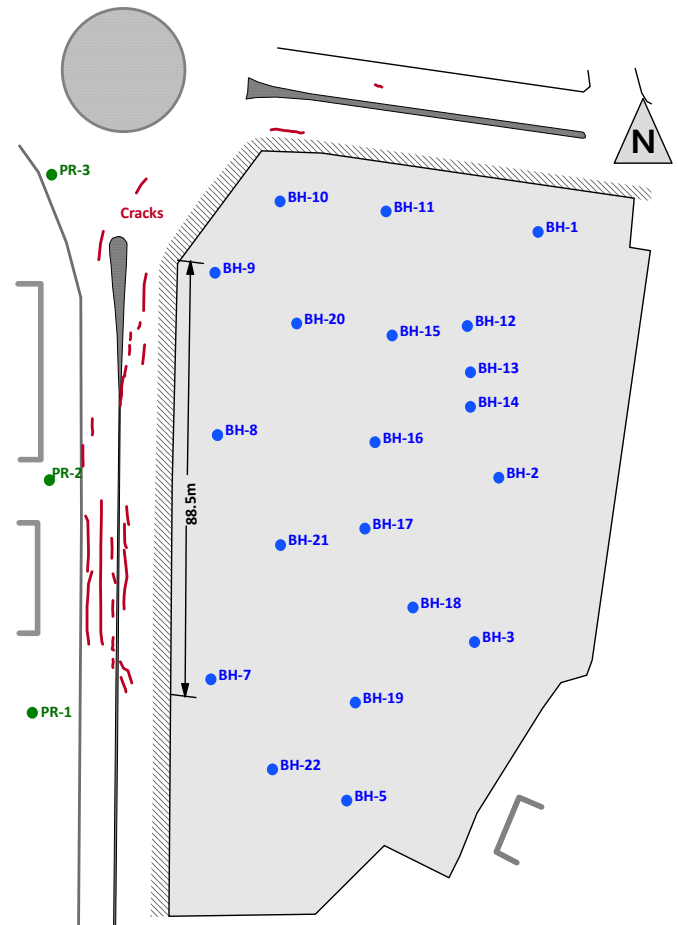
The distress and deformations in the shoring system itself were accompanied by the development of longitudinal cracks in the major road at the western boundary, at distances of ~8m, ~13m and ~ 17m away from the edge of the excavation, with a perceptible differential downward movement across some them.

volumes of soil/rock. A schematic plan of the site which shows the mapped cracks (in red) is provided in Fig. 1.

Fig. 1. Plan view of the site showing the cracking in the roads

At this point, emergency remedial measures were put into effect. These included the closure of the main road to traffic and the initiation of round the clock backfilling operations along the affected side of the excavation. The backfilling operations proceeded to eventually reach a height of about 20m from the base of the excavation. The cracks along the road were “sealed” to prevent the infiltration of rain waters which could further destabilize the failing mass. The system was stabilized and no further significant movements were observed, either along the portion of the facing which remained exposed (top 8m) nor in the cracks along the road to the west.

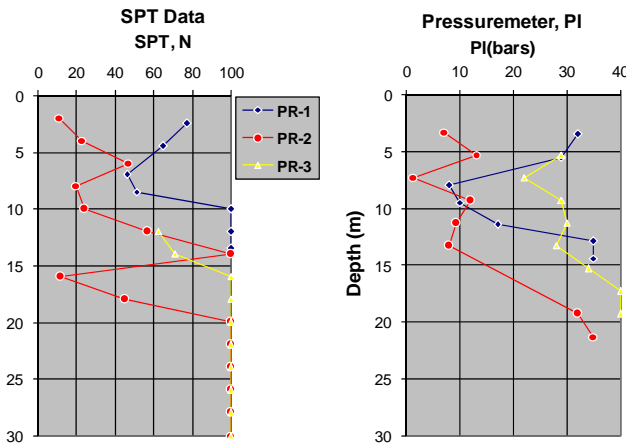
Fig. 2. Field test results from the second investigation effort

A number of significant differences can be identified between the earlier geotechnical investigation and the one carried out in the days following the shoring system distress. The new subsurface model (Profile 2) consists of three “layers” or strata assigned the following engineering characteristics:

- ❑ Clayey Sand:  $\gamma=19\text{kN/m}^3$ ;  $c=25\text{ kPa}$ ;  $\phi=25^\circ$ .
- ❑ Silty Marl/Marl:  $\gamma=20\text{kN/m}^3$ ;  $c=50\text{ kPa}$ ;  $\phi=25^\circ$ .
- ❑ Marly Limestone/Marl:  $\gamma=22\text{kN/m}^3$ ;  $c=75\text{ kPa}$ ;  $\phi=25^\circ$ .

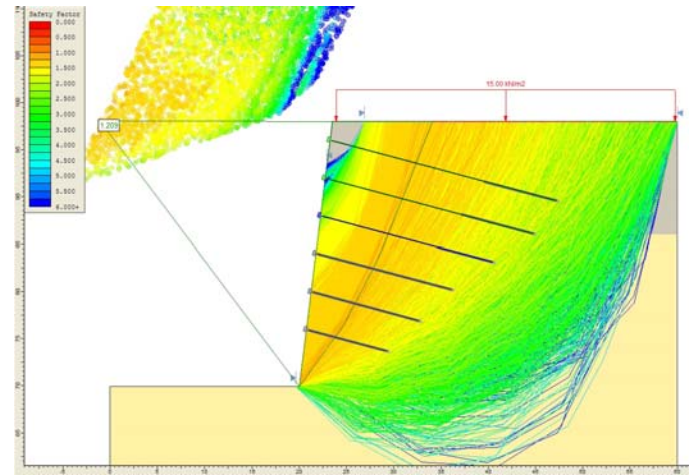
The executed shoring system design was evaluated at a first stage by using limit equilibrium analyses. The behavior of the system was explored in reference to a target global safety factor using un-factored soil and material parameters. We considered that an appropriate target global factor of safety for conditions such as the ones relevant in the project under consideration would be  $FS \sim 1.5$ . The analysis tool used was the specialized software SLIDE by roscience. The results of the runs and limit equilibrium analyses conducted using both Profile 1 (original subsurface parameters) and Profile 2 (strata characteristics and parameters as established in the later site investigation effort) are presented in Figs. 3 and 4. The minimum global safety factors obtained for profiles 1 and 2 using non-circular failure surfaces, were 1.209 and 0.921 respectively. These numbers indicate that the original design was not satisfactory even with the subsurface model and associated characteristics used and that the second profile with its relevant the strength parameters indicates failure conditions ( $FS < 1$ ) as observed. It is interesting to note that the mobilized mass indicated by these analyses appear to correlate well with the observed crack patterns and distress.

Fig. 3. LE analyses Profile 1. With all surfaces.  $FS_{min} \sim 1.21$ .

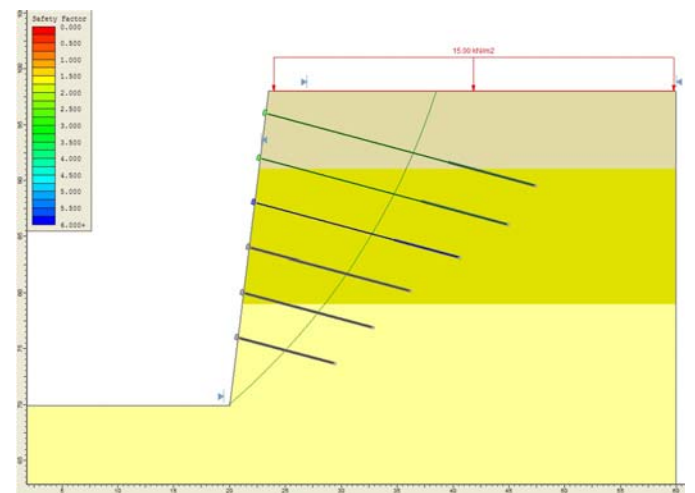
Fig. 4. LE analyses Profile 2. Critical surface  $FS_{min} \sim 1.21$ .

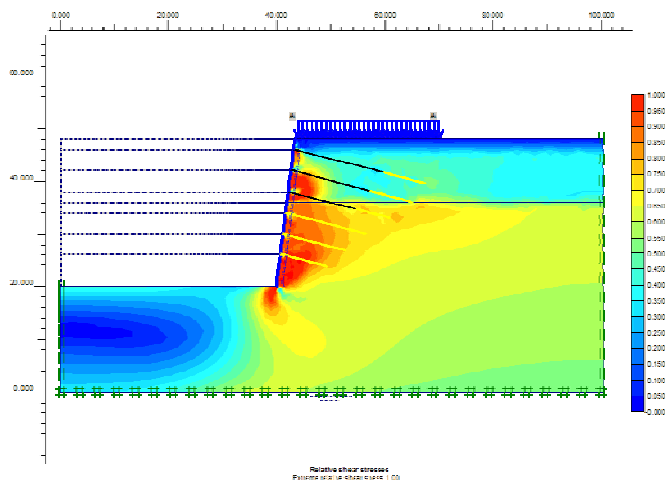
- ❑ The zone between the last row of anchors and first row of nails experiences very high levels of shear stress ratios and the development of plastic points associated with significant deformations. This finding correlates well with the observed distress in the shotcrete facing at that particular level, prior to reaching the bottom of the excavation. This point is discussed further in the monitoring section of this paper.

- ❑ As the final excavation step is reached, a large concentration of plastic points develops at the toe of the slope and extends upward and outwards, without developing full “failure conditions” in case Profile 1 model characteristics are used, whereas clear failure patterns are evident for Profile 2. Interestingly, tension points are noted at or near the ground surface, starting at a distance of ~12-15m behind the face of the excavation, which correlates well with the observed cracking and distress patterns shown in Fig. 1.

Fig. 6. FEM Profile 1. Relative shear stresses  $\tau/\tau_{max(m-c)}$ .

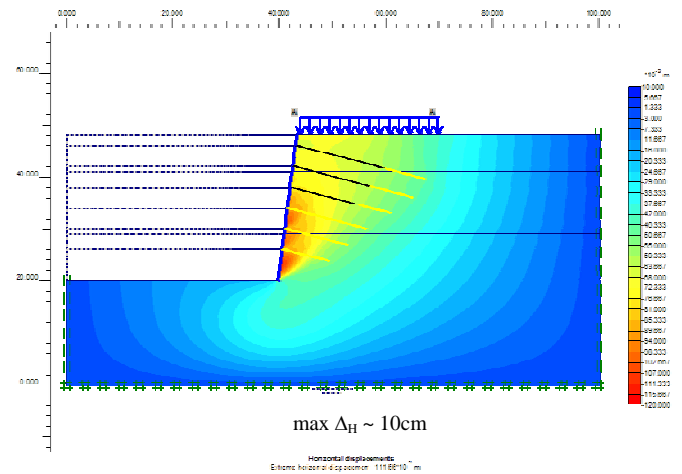
- ❑ Finally, for the case of Profile 2, the outwards horizontal deformation patterns at the facing match (in form) and even to some extent the general magnitudes (on the order of ten cms as a maximum) the patterns observed in the survey monitoring data, a typical sample of which is shown in Fig. 7.

Fig. 7. FEM Profile 2. Horizontal displacement contours.

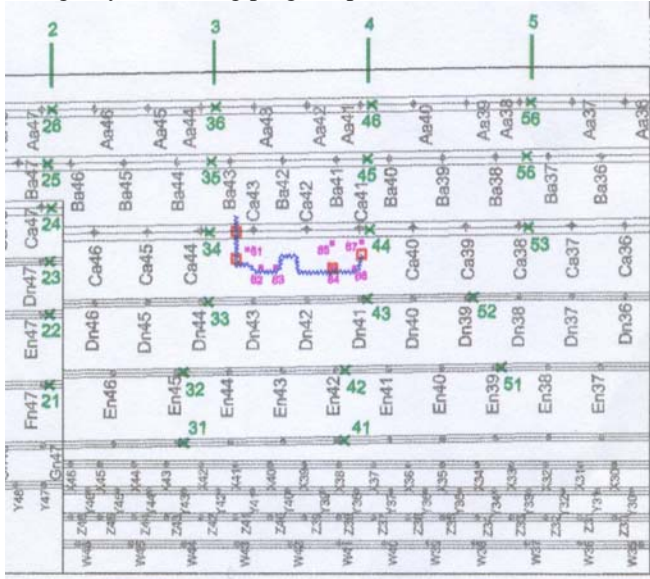
Fixed references were placed at some anchors heads locations and other points along the shored face. These references points were regularly monitored for displacements in the three directions. The relevant reference points along the section which is the subject of this paper are shown on Fig.8. On that same figure blue lines mark the locations which showed significant distress in the shotcrete facing as the works proceeded to the final grades. All the survey data made available to us for the relevant section were analyzed and plotted along various vertical alignments through the section. Typical horizontal (Y direction) deformation measurements along alignment 3 are presented in

Fig. 8. Partial view of the monitoring points along the section (surveyed points in shown in green)

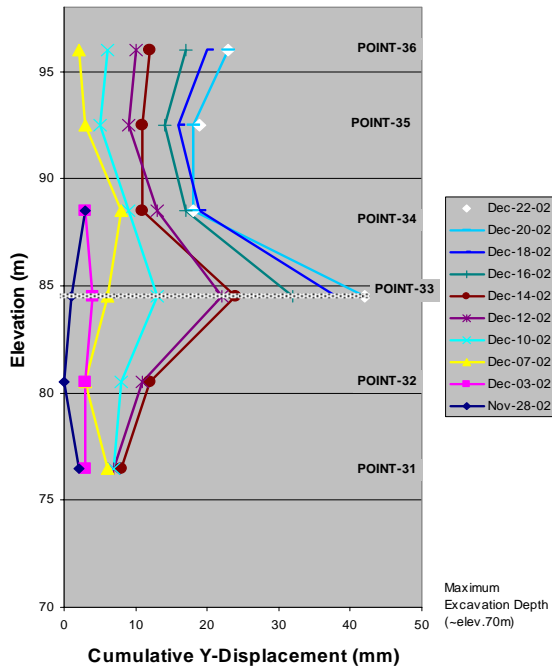
Fig. 9. Horizontal movement along alignment 3. The grey line marks the backfilling elevation obstructing further readings.

It is clear from these figures that the movements started to increase at an alarming rate from approximately December 10

and stabilized significantly after the remedial backfilling was implemented.

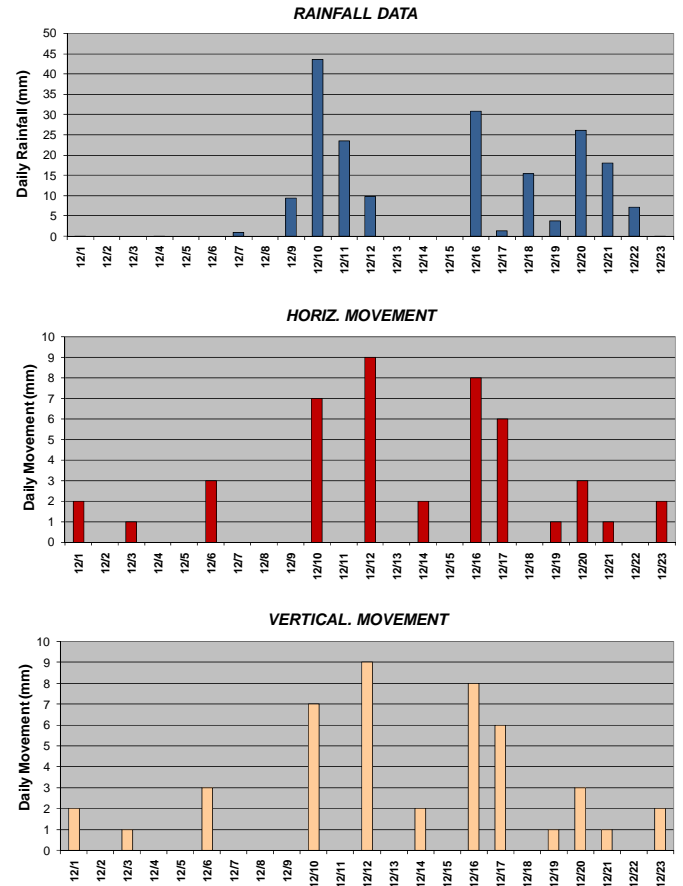
In order to investigate the effect if any of the rainfall which fell over the area on the observed patterns of movement, the results for the period spanning from Nov 28 to Dec. 22nd for the point of maximum deformation along alignment 3 (point 33) were plotted and they are presented in Fig. 10 along with the corresponding average rainfall data obtained from the Beirut International Airport weather station.

Fig. 10. Incremental horizontal and vertical movements at Point 33 with average rainfall data for same period.

- ❑ Water reaching the soil/rock strata along the distressed side was clearly a contributing factor to the observed failure, as the displacements are well correlated with increased precipitation and more importantly, resulted in measured very low strength in the post-failure exploration boreholes (particularly PR-2)
